Michael Immler
Publicly appointed and sworn expert
for the vulcanizing industry

Test order / expert opinion

Concerning :2 tires with 2 prepared repair points each

Make :Michelin

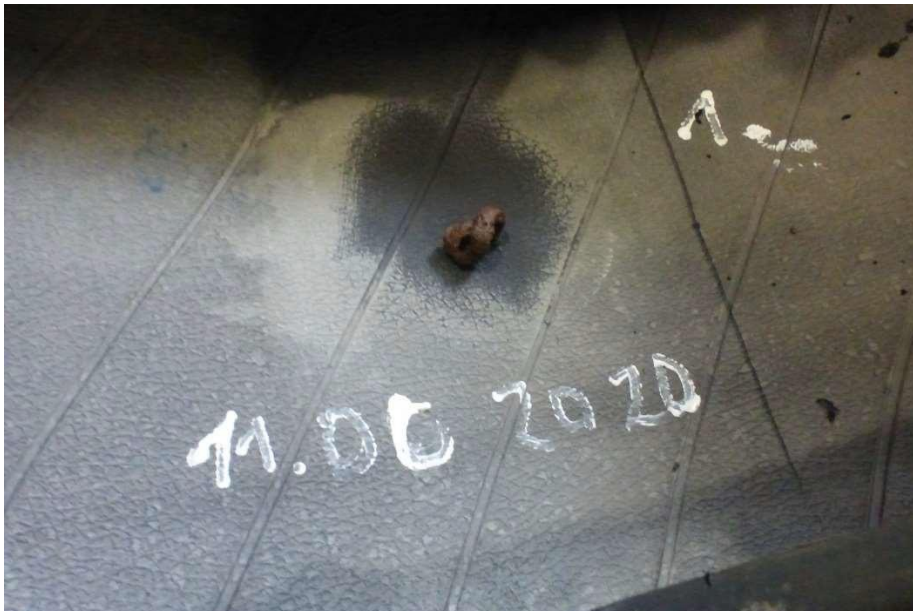
All repair areas were prepared with a hole channel with a diameter of approximately 5 mm and an angle of approximately 90° to the tread.

The hole channel was not milled out; the repair was carried out according to the manufacturer's instructions.

The repair material with the date of manufacture 11.06.2020 was used

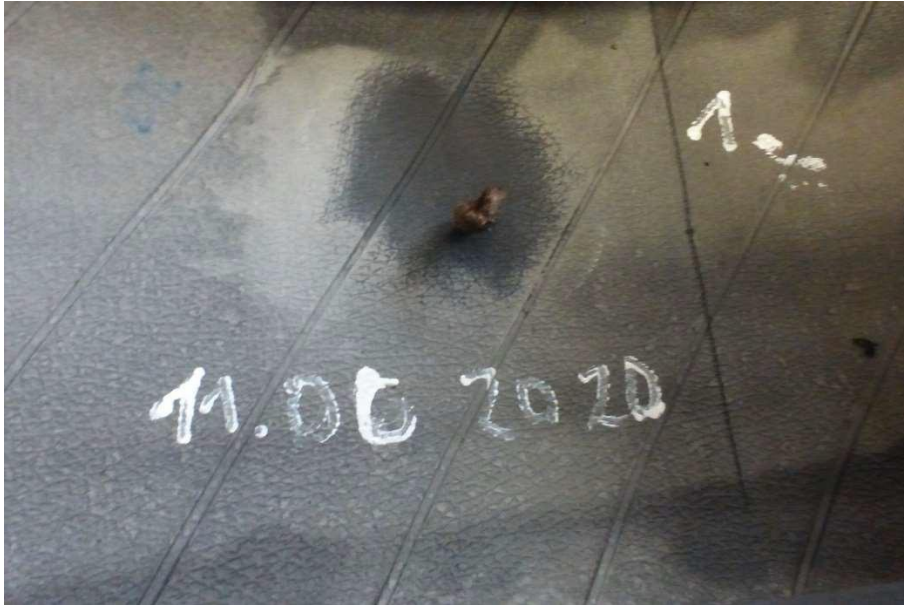
The repair material was inserted into the hole using the awl included in the repair kit, and the hole was sealed with the repair material.

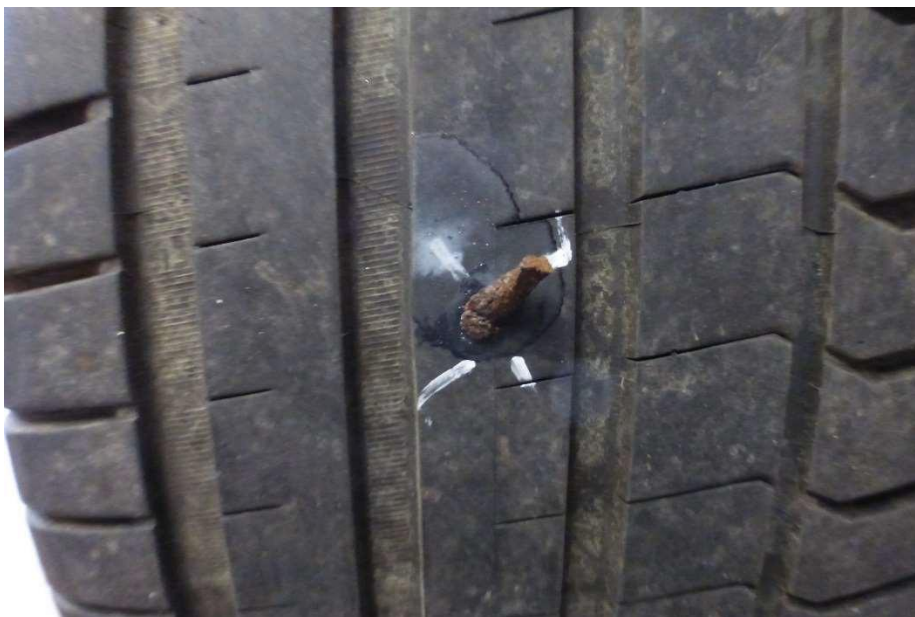
The remaining external protrusions of the repair material were trimmed flush after the repair was completed.

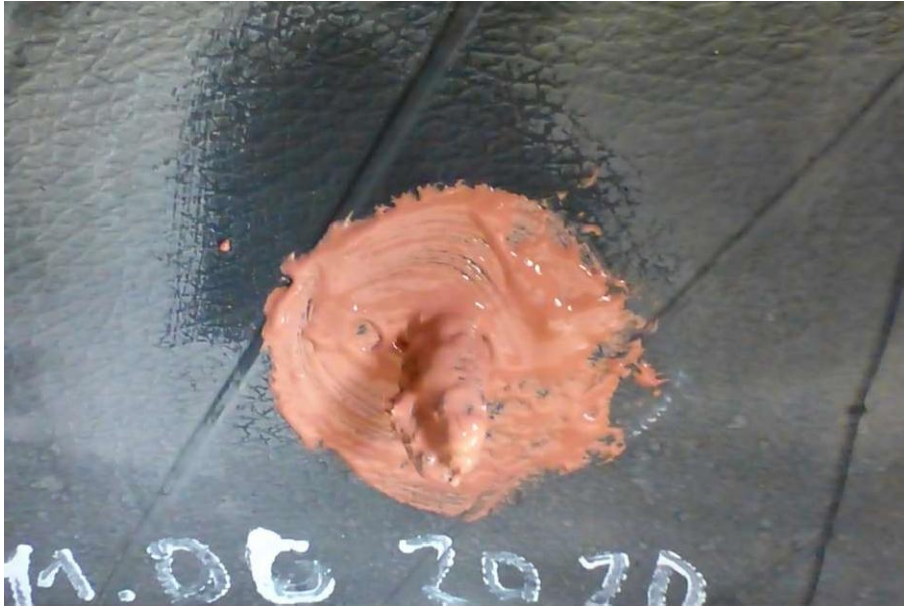
Finally, the liquid patch was applied according to the manufacturer's instructions, in accordance with the RILI for the repair of pneumatic tires.

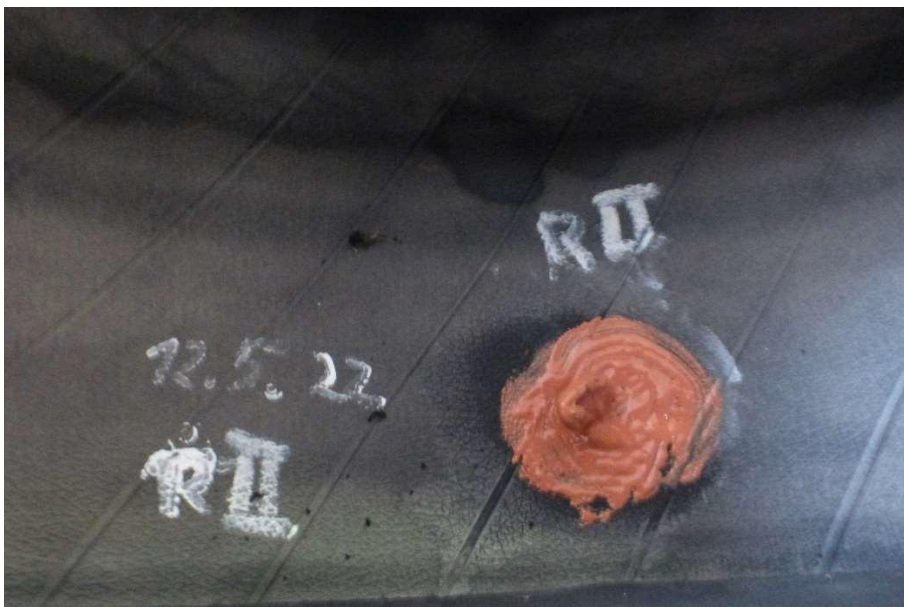
Repair point 2 on tyre 1 180° opposite repair point 1

All repairs were carried out in accordance with the specifications of the repair material manufacturer. Only the positioning of the hole channels was done in different areas of the tire.

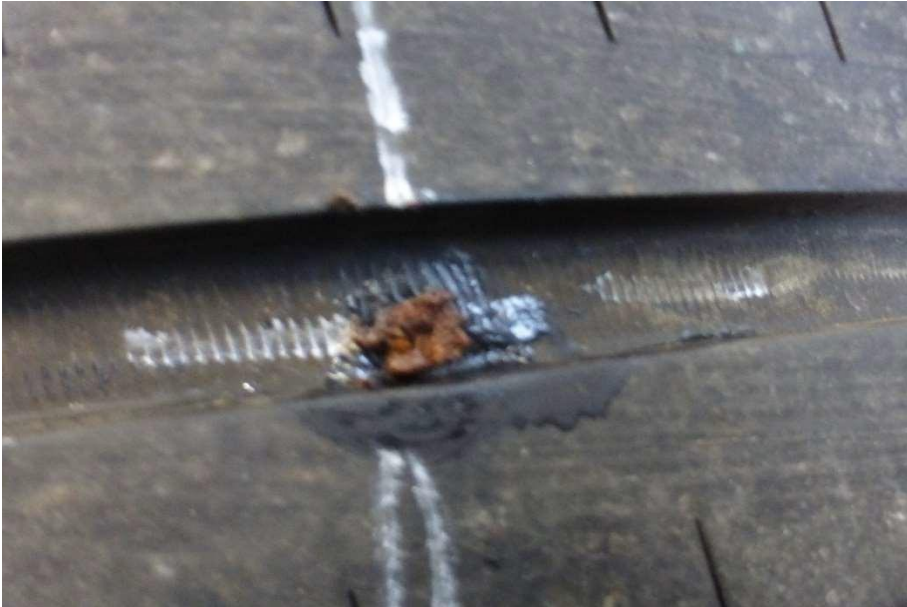
Repair point in the tread base of tyre 1 approx. 180° opposite repair point 1
Material Manufacturing date is given as 12.05 2022

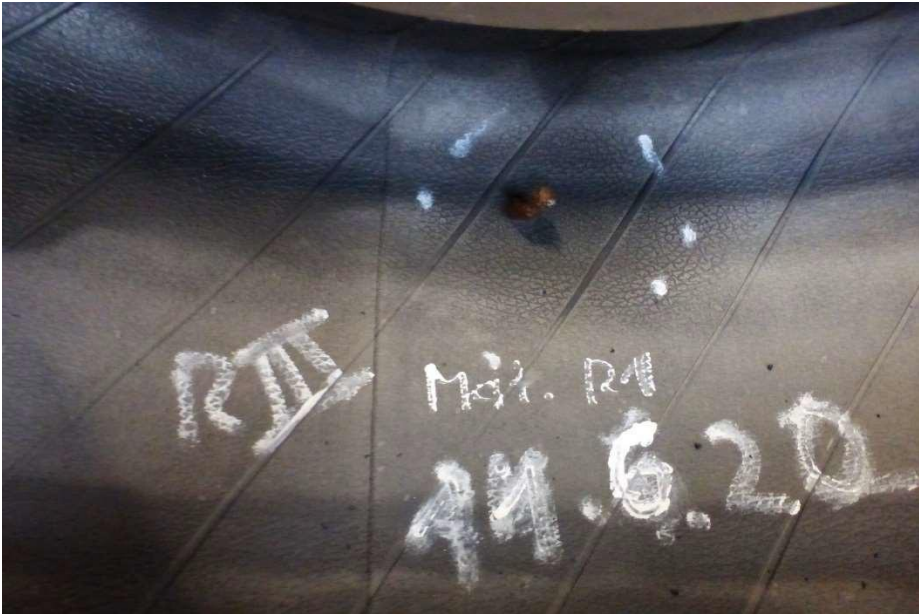
Tyre II with repair points No. 3 and No.4

In the case of tire II, the hole channel of repair 1 was installed in the tread and a diameter of approx. 5mm. The repair site was positioned in the outermost repairable area of the tread.

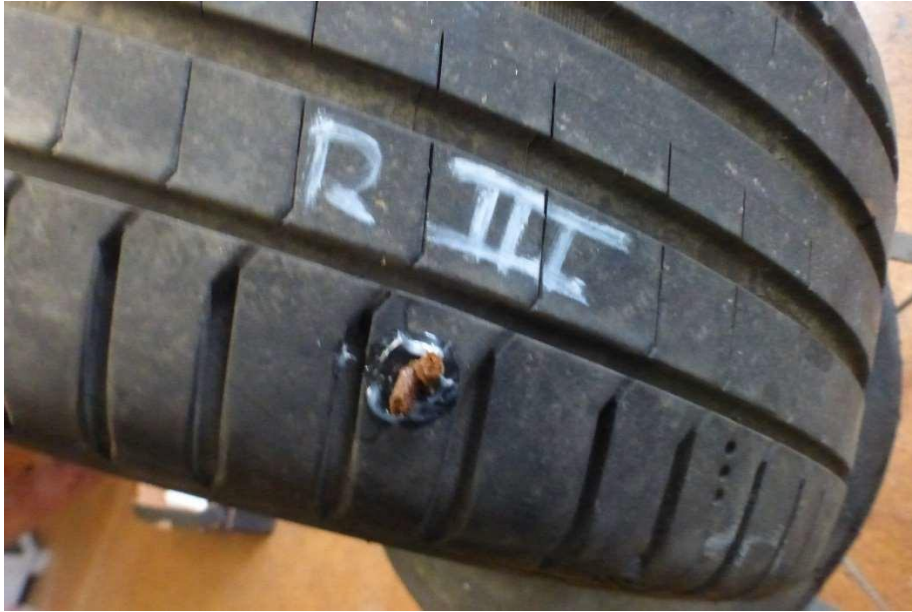
Location of the repair site in the outer area of the tire tread

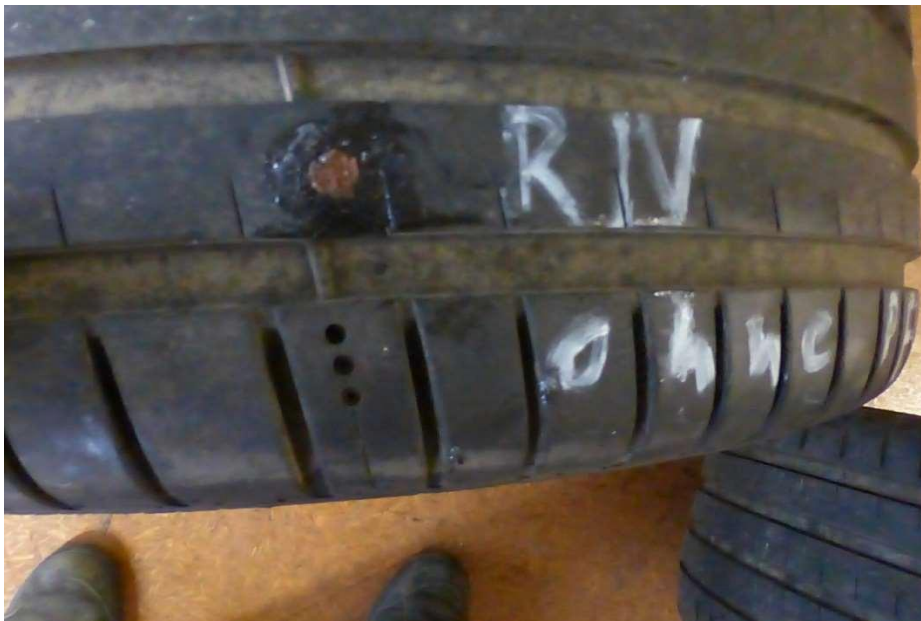
Repair site 4 was incorporated without liquid patch.

Reason: there are states in which a liquid patch is not mandatory. For this reason, the high-speed test was carried out with tyre 2 with a repair area without plaster.

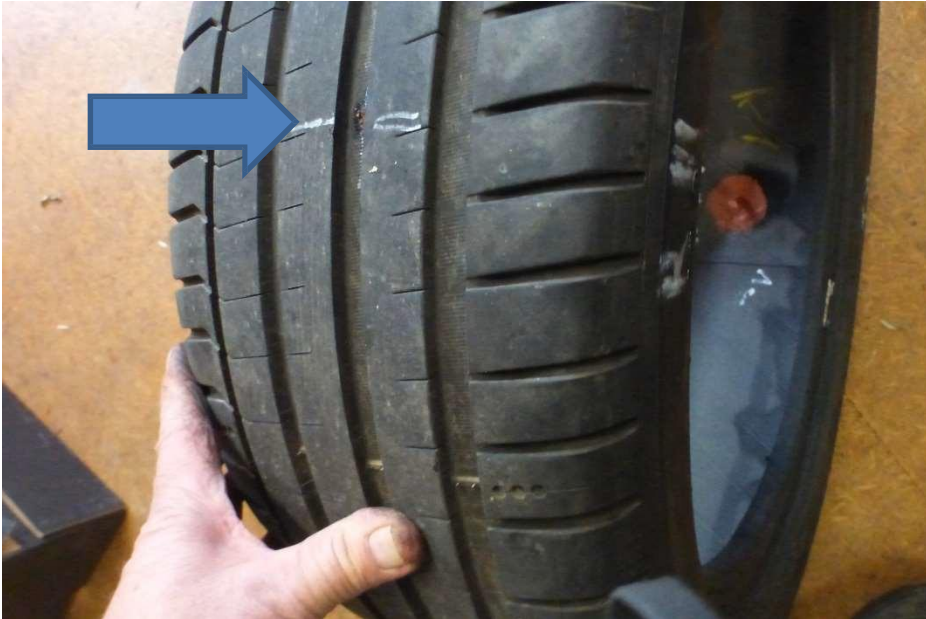
Repair points on tyres 2. The repair point is visible approx. 180° from the Repair site 4

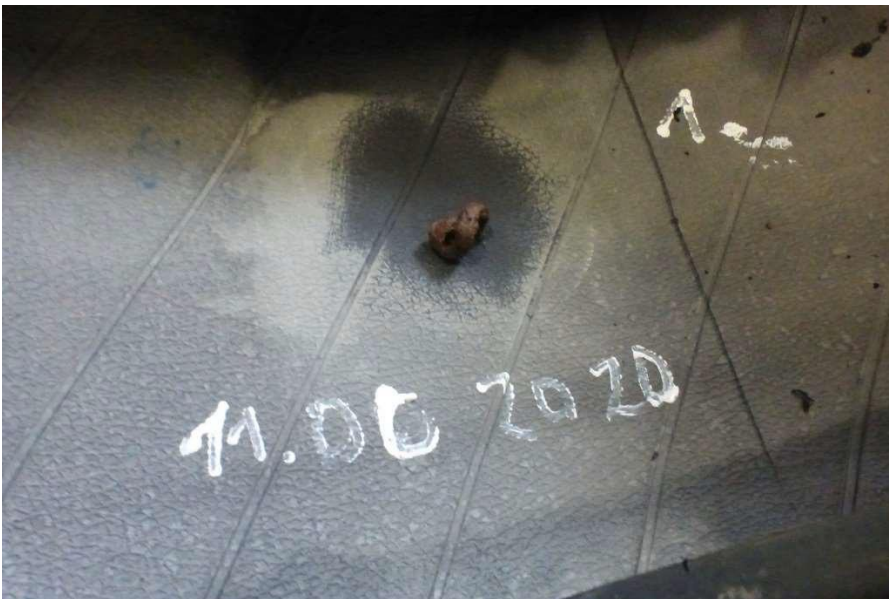
Cleaned repair site with inserted Safety Seal string. Date of manufacture 11.06.2020

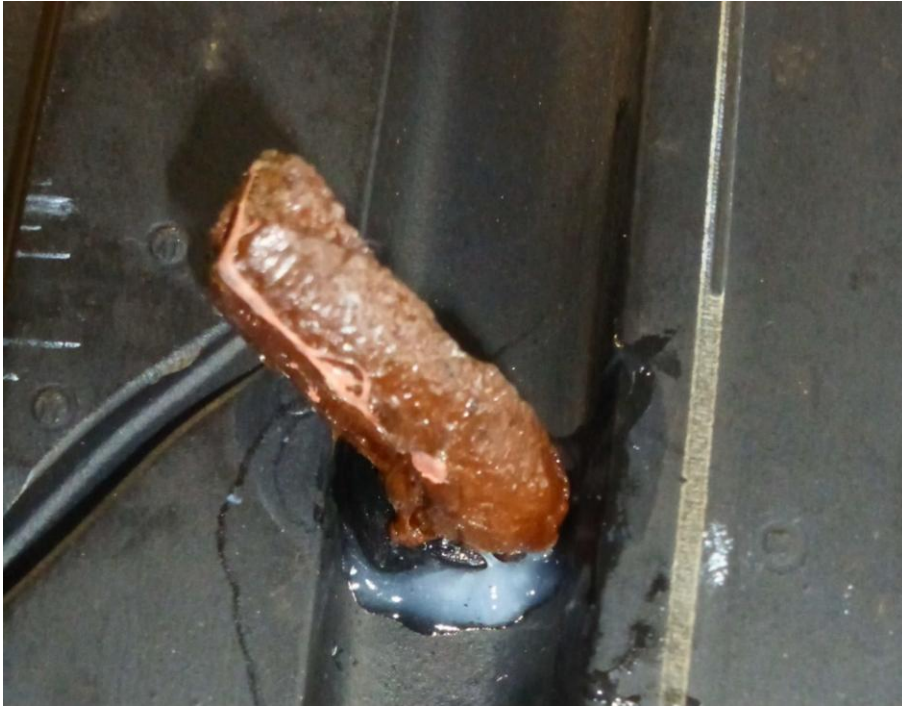
The hole channel has been closed with Material Safety Seal self Vulcanizing / String

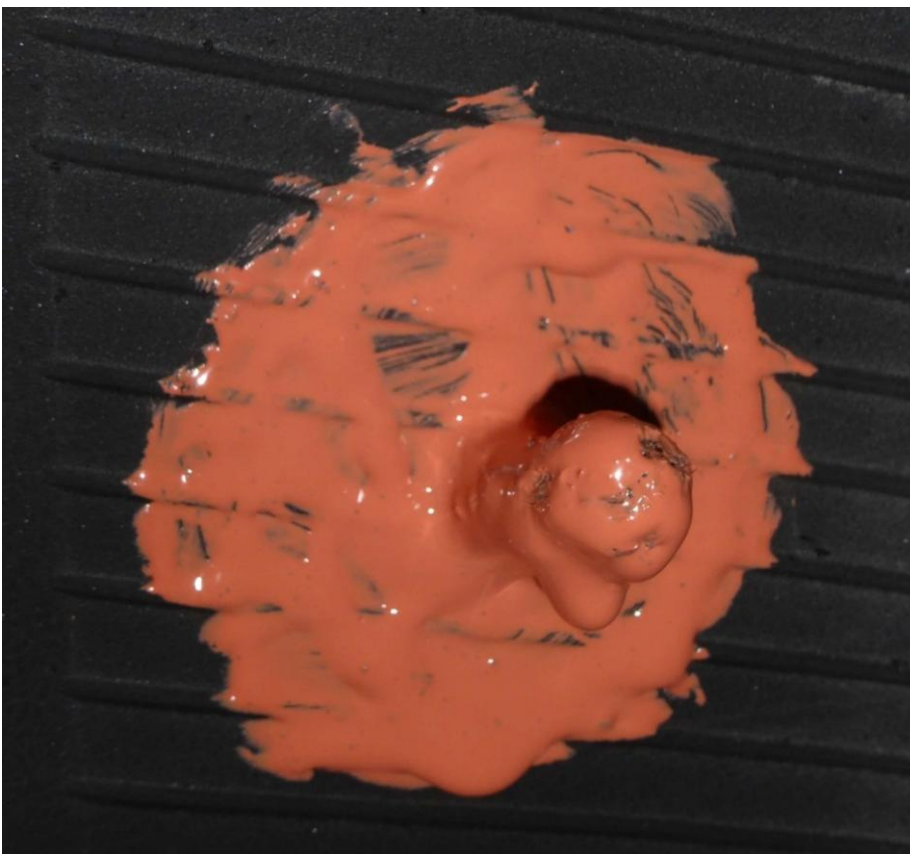
Liquid Patch was added and the repair area was sealed inside
